PHE Report:

Water System Assessment

Site of Inspection:	Stewart Community Water System (CWS)
Date of Inspection:	9 Jul 2012
Report Sent to:	Maureen Tarrant, Chief Administrative Officer; cao@districtofstewart.ca Chad McKay, Director of Public Works; operations@districtofstewart.com
Report Copied to:	Azreer Gill, EHO; Shane Wadden EHO
Report Prepared by:	Dave Tamblyn, PHE
Date of Report:	17 February 2015

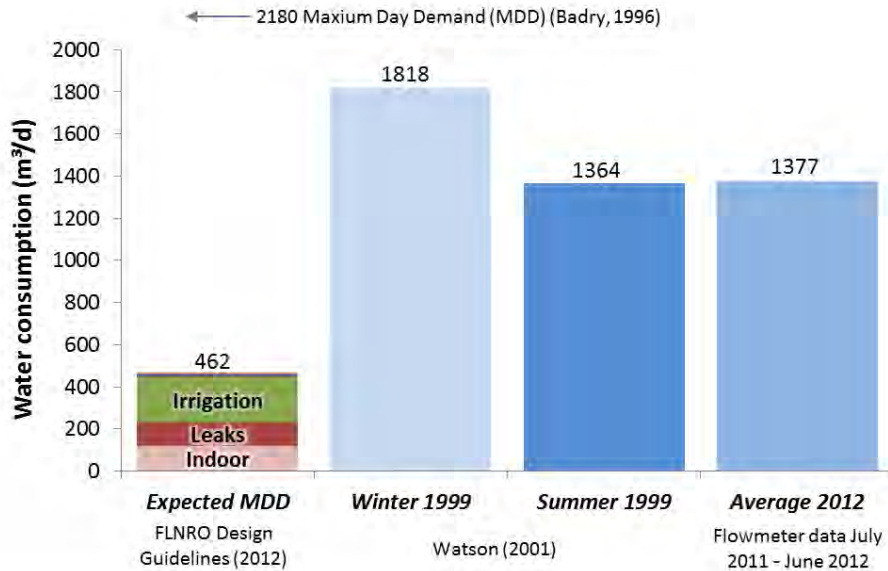
Figure 4. Expected and Actual Water Demand.

Ordinarily, MDD might be expected to be 2 to 3 times higher than ADD. In the case of Stewart CWS, however, the ADD (1477 m³/d) is 3 times higher than the MDD *predicted* by the FLNRO guidelines (462 m³/d) – *about 7.5 times higher than expected*. Badry (1996) reports an even higher MDD (2180 m³/d), and Watson (2001) reports similar high ADD values (**Figure 4**).

Why is Stewart's water consumption 5 to 10 times higher than expected? Anecdotal reports suggest that some residents leave the water running throughout the winter. Residents may not consider water valuable and worth conserving because (i) there are no residential water meters installed, (ii) the District reportedly does not have any specific charge for water, and (iii) it rains frequently (at least 75 mm month). Another possible explanation for the very high water consumption is leaking mains. It is common that municipal water systems will lose 10% to 25% of their product due to leakage and unaccounted water usage (FLNRO includes 24% leakage), but Stewart's losses could be much higher.

Component	Recommendation
1. Demand	<ul style="list-style-type: none"> (a) Investigate why water consumption is so high. (b) Provide detailed water meter records for each well and any summary reports to Northern Health for review. (c) Ensure water service is off and lines are empty at unoccupied properties. (d) Consider hiring a specialist contractor to carry out an acoustic water loss survey. (e) Educate residents about the value of water and best practices for winterising – shut off the main valve on the water line and drain or blow out the interior plumbing if a residence is not going to be heated over the winter months..

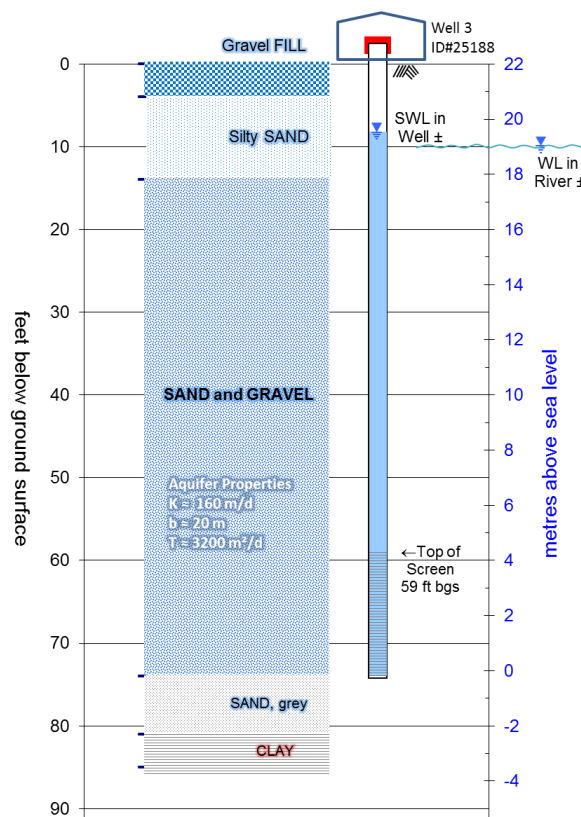
Figure 7. Aquifer Stratigraphy (Badry, 1996)

I have included an unofficial aquifer classification worksheet in the **Appendix**. Recharge to the wells is expected to be meteoric (precipitation) given the abundant precipitation, granular surface sediments, and cold climate. Areal recharge might be in the range of 20 to 60% of precipitation (In the case of wells 1 and 2, recharge is enhanced by the Bear River to the north, and for well 3, runoff from the rock outcrop (mountain) immediately to the west. Well logs are not available for Wells 1 or 2. Well 3 log is included in the **Appendix**. The commissioning report for Well 3 (Badry, 1996) found that the *aquifer transmissivity* was very high at 3,350 to 29,700 m²/day, and that the *hydraulic conductivity* of the sand and gravel in the aquifer was at least 160 m/d.

Badry (1996) reported a very high well capacity, in excess of 1500 gpm, and *specific capacity* of 4200 m²/day for Well 3 (aka P3). She suggested a wellhead protection area (WHPA) of 280m long × 120m wide, as illustrated on **Figure 5**. Although Well 3 is far from the Bear River, there is a small tributary to Rainey Creek about 50 m northwest, so surface water influence (GUDI) cannot be ruled out. Well 3 has excellent documentation (Badry, 1996) including a 24h pumping test and 2h recovery test. The well depth is 74 feet, and the well screen runs from 59 to 74 ft bgs. The estimated hydraulic conductivity of the coarse sand and gravel is at least 160 m/d (**Figure 7**).

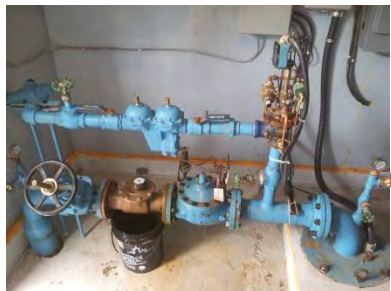
Well 1, lag, 50 hp throttled

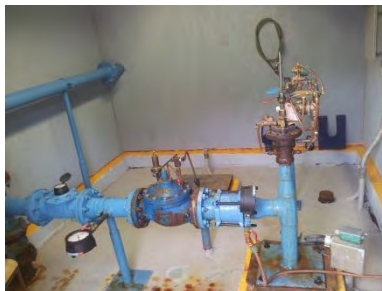
Well 2, lead, 30 hp

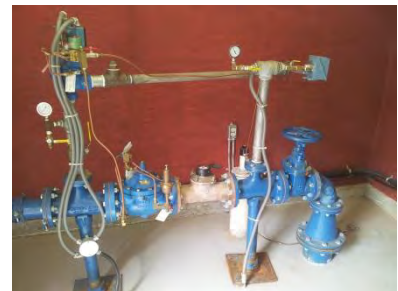
Well 3, backup, 50 hp with genset

If a reservoir is not feasible at this time, it may be useful to ***investigate making the backup genset for Well 3 activate automatically based on a pressure switch.*** This would prevent the system depressurizing and allowing ambient groundwater to seep in, contaminating the water mains.

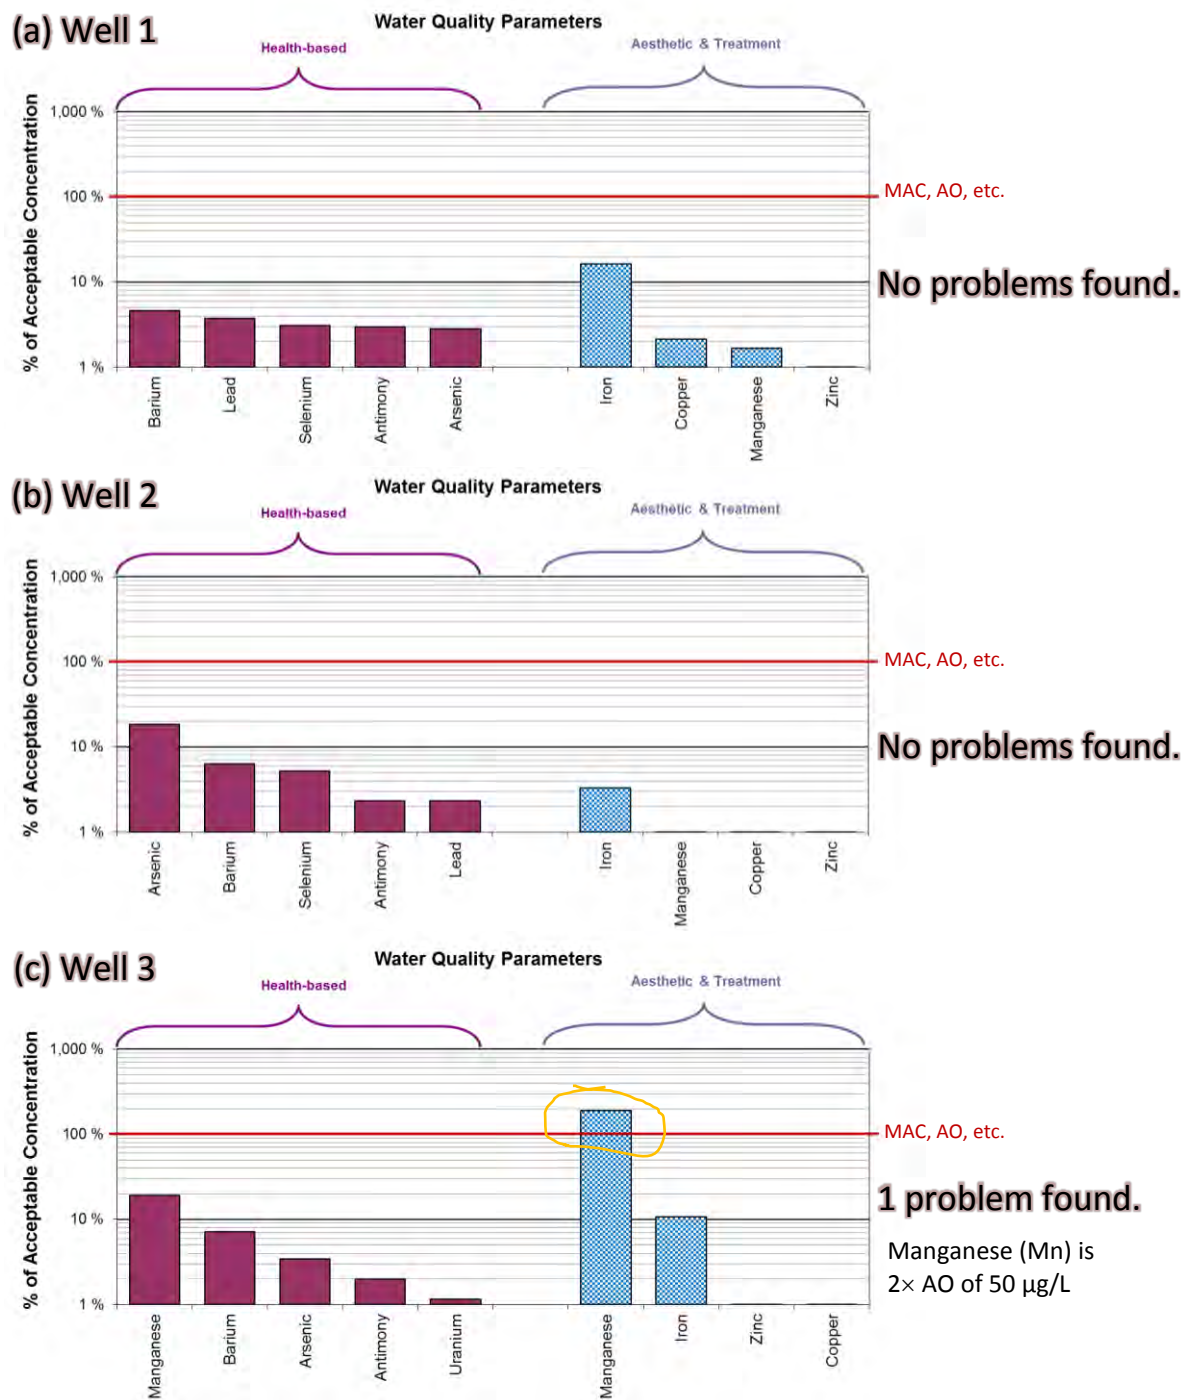
Figure 11. Highest health and aesthetic parameters – (a) Well 1 , (b) Well 2, (c) Well 3

Figure 11 below plots the *highest* chemical concentrations measured in the 2008 Metals Scan, relative to their guideline¹. All parameters tested were acceptable (below the guideline), with one exception. The level of manganese in Well 3 (backup) is slightly above the aesthetic objective (AO) set by Health Canada on the basis of black staining and bitter metallic taste. Since this well is currently a backup, for emergency use, the level of manganese poses no concern.

¹ For example, Iron in Well 1 is about 16%. The AO guideline for Iron is 300 µg/L, so 16% is $0.16 \times 300 = 48$ µg/L.

parameters are important to any consideration of treatment, and the next chemical sample is overdue.
 → **Resample all 3 wells for Northern Health list of standard chemical parameters.**
